A Landslide Risk Management Approach for the  
Stillwater to Ngakawau Rail Corridor (SNL96 to 126km)  
in the Lower Buller Gorge, New Zealand

A thesis submitted in partial fulfilment of  
the requirements for the degree of

Master of Science in Hazard and Disaster Management

**UNIVERSITY OF CANTERBURY**  
**2012**

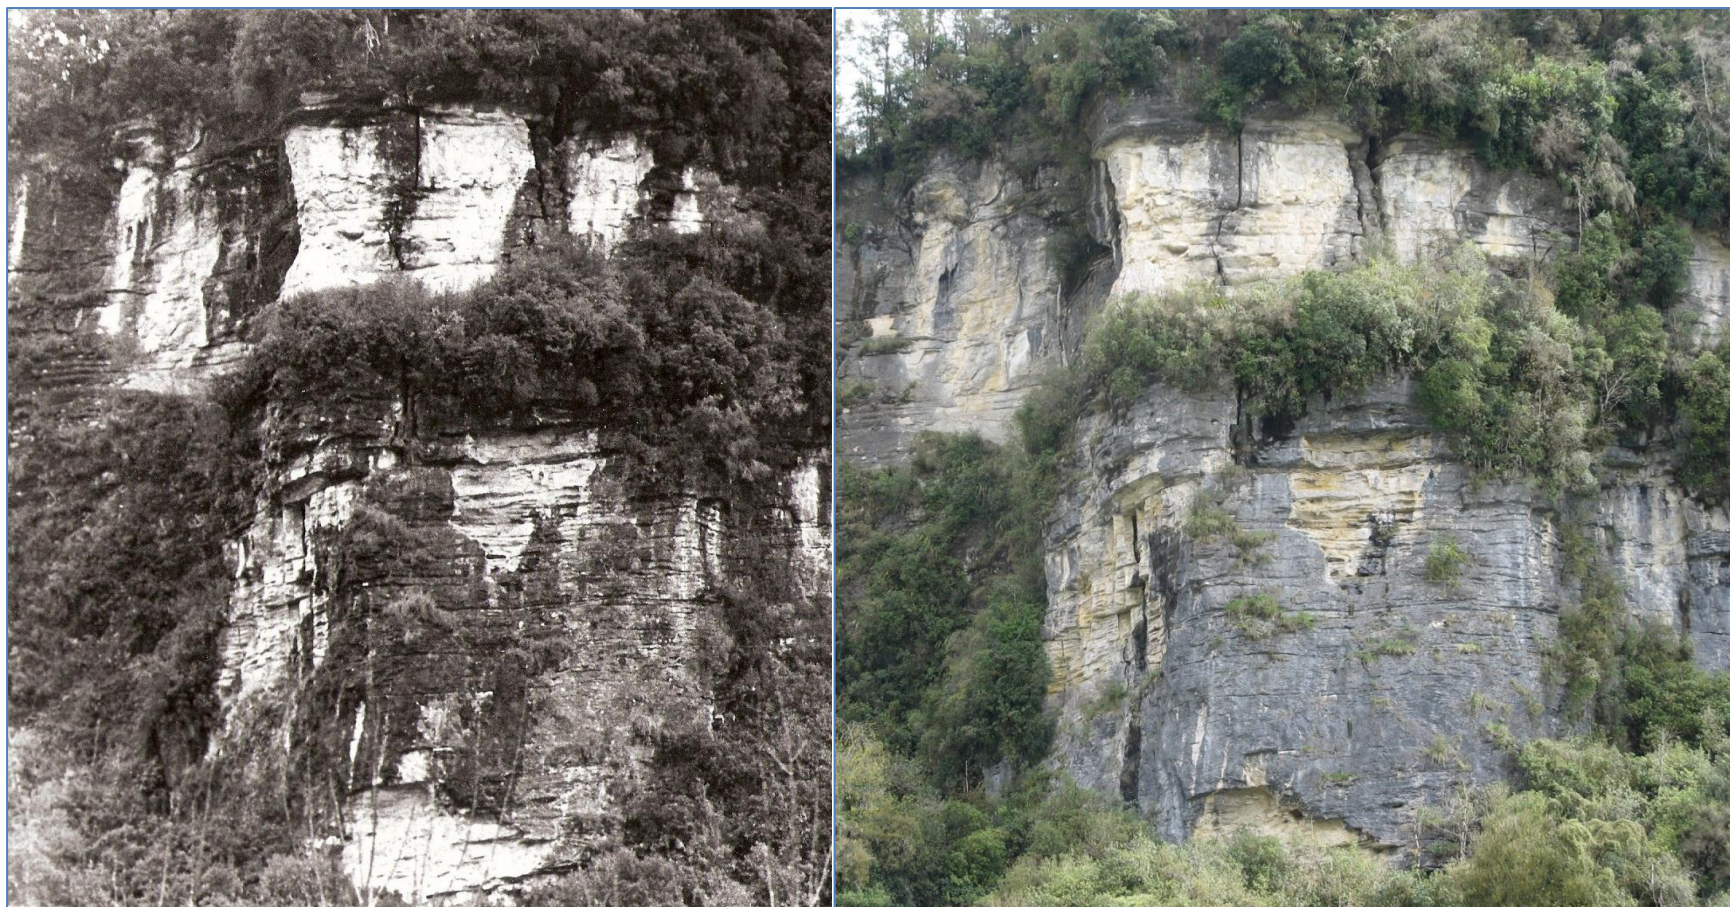
**Figure 3.1: Whitecliffs profile comparing 1979 (left) and 2011 (right) photographs**

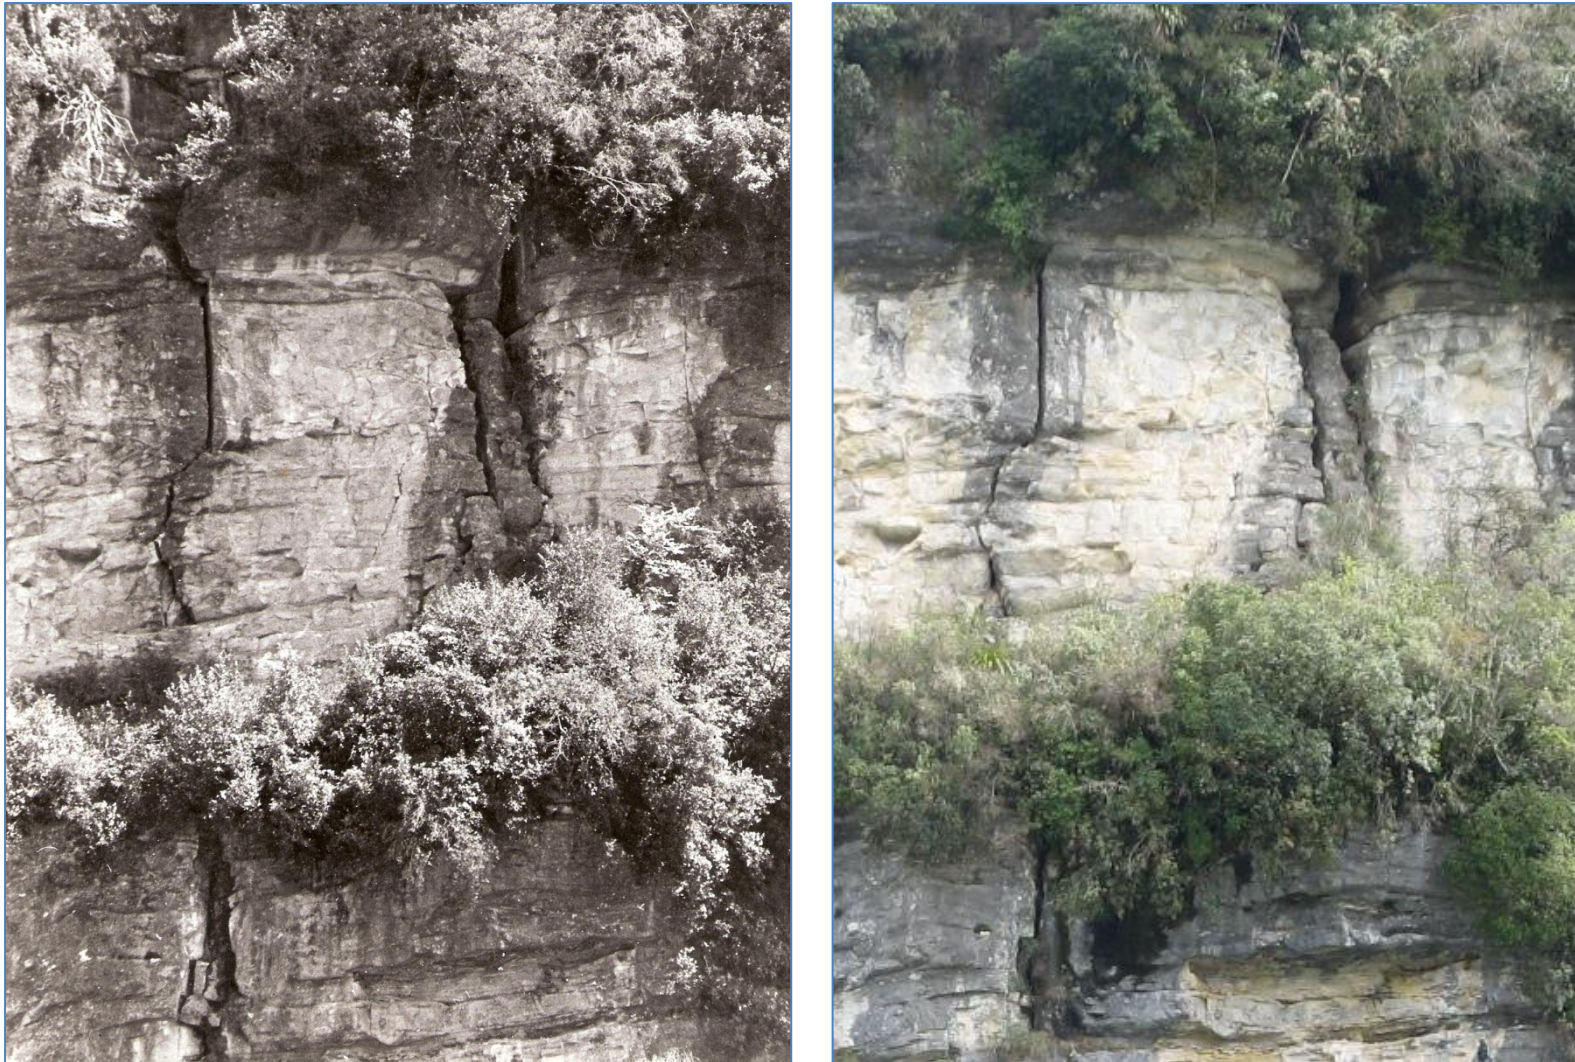
**Figure 3.2: Defects in near vertical limestone outcrop at Whitecliffs in 1976 (left) and 2011 (right).**

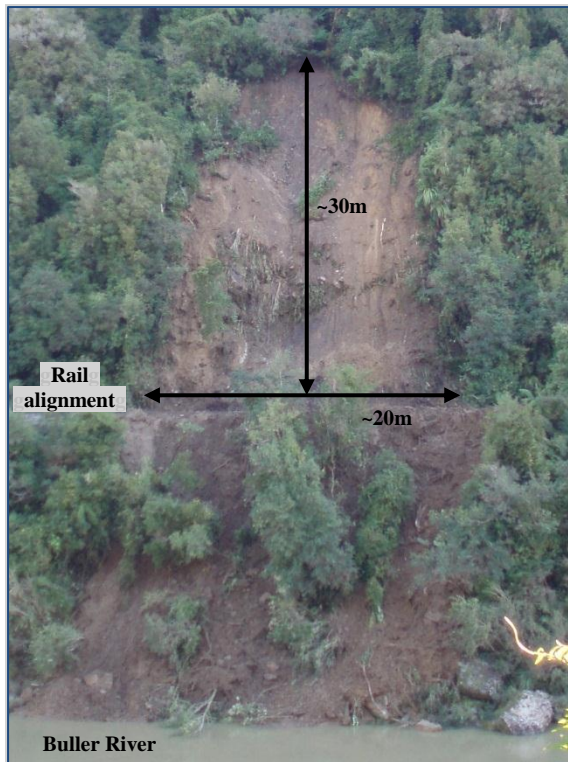
**Figure 3.3: View of landslide at SNL112.96km from State Highway 6 (based on Ontrack, 2006).**

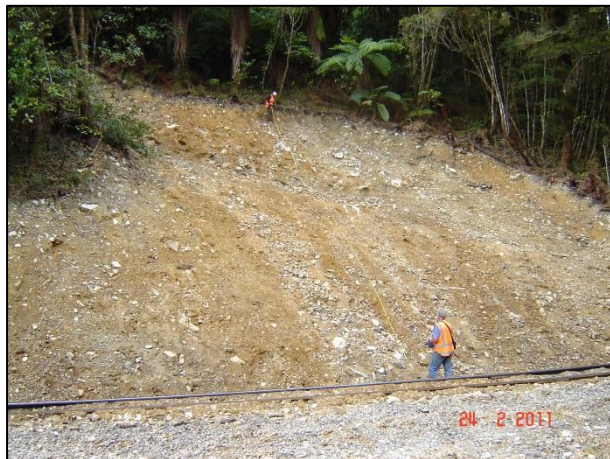
**Figure 5.4: Shallow colluvial failure in clay-bound angular gravel near SNL96.95km**

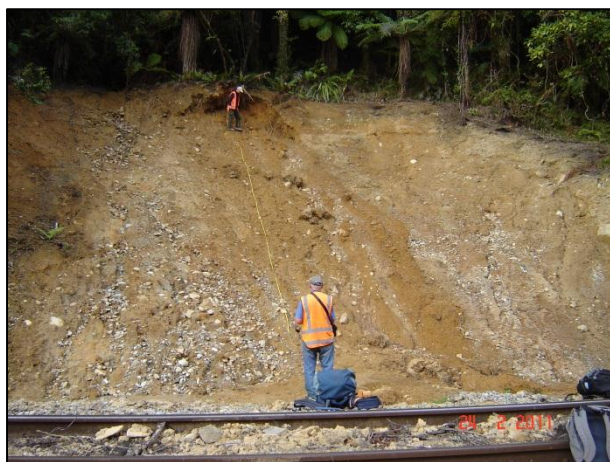
**Figure 5.5: Shallow colluvial failure in clay-bound alluvial gravels near SNL95.60km**

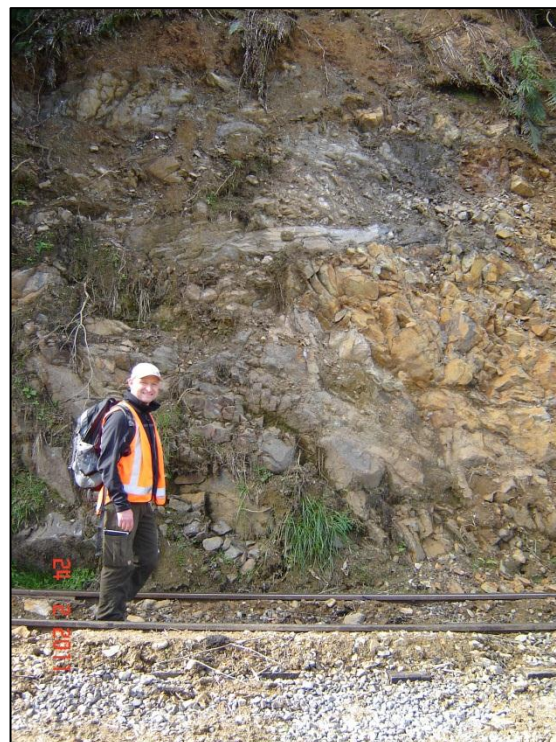
**Figure 5.6: Shallow regolith failure on Greenland Group bedrock near SNL95.30km**

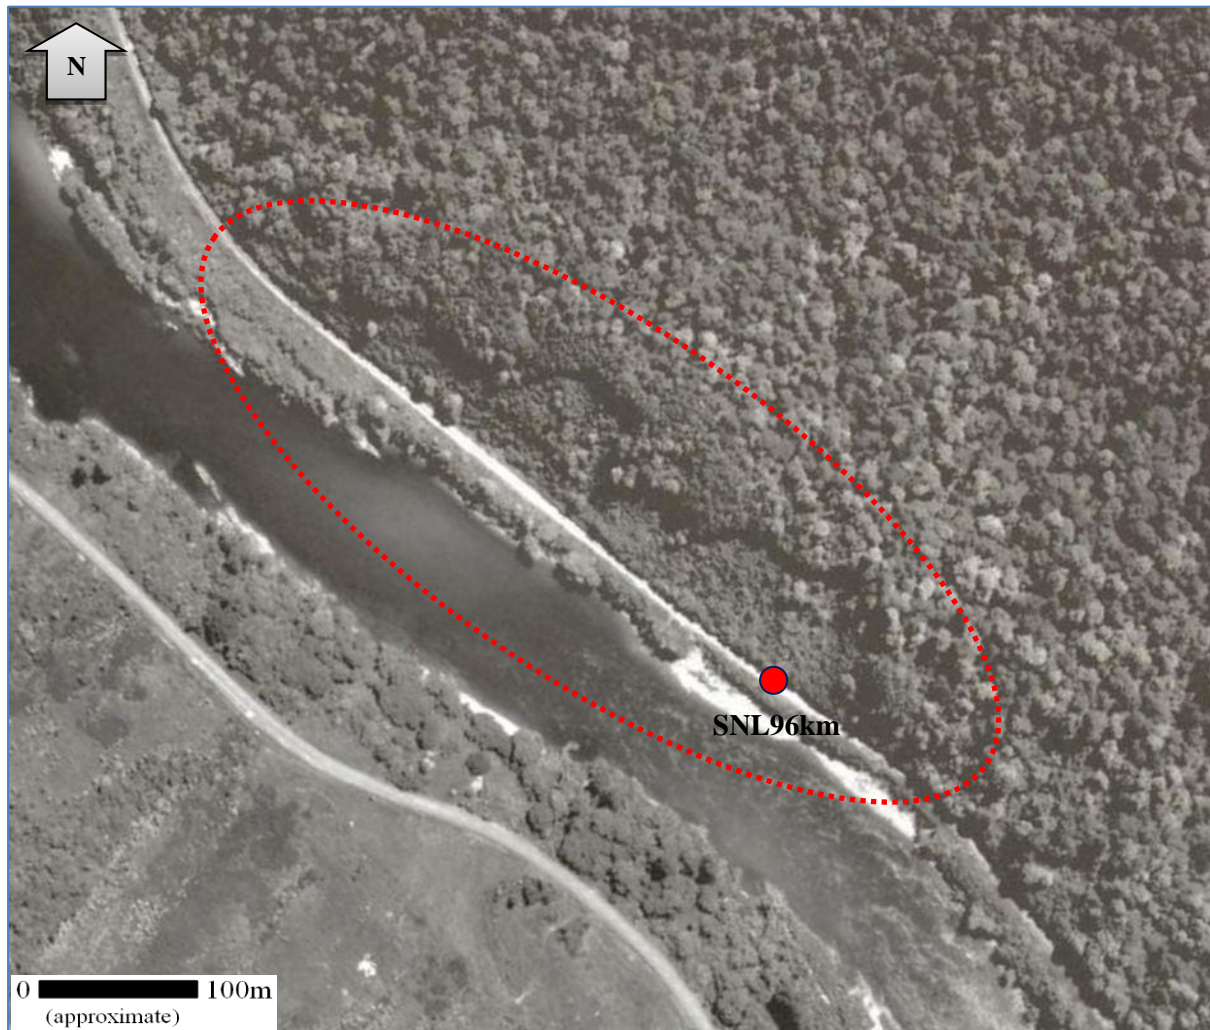
**Figure 5.7: Shallow regolith failures (circled) visible in the vicinity of SNL96km in aerial photography from 1985. Aerial photograph interpretation shows these are not related to track construction.**

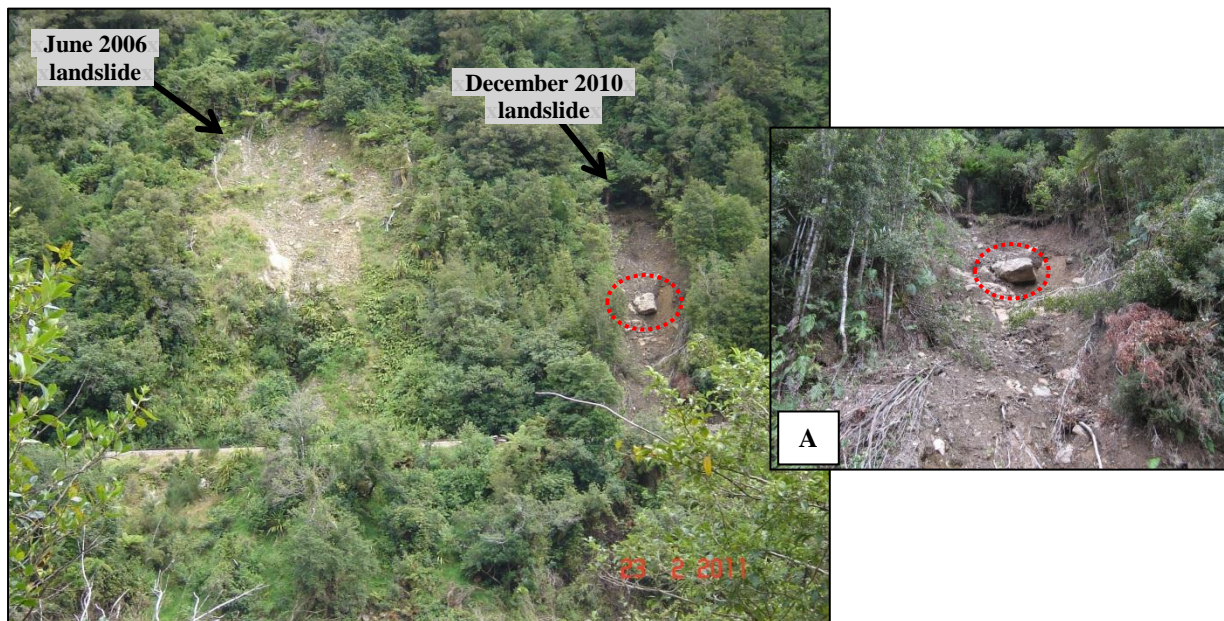
**Figure 5.8: View of partially re-vegetated June 2006 landslide at SNL112.96 (lefthand side) and recent December 2010 landslide, with a 10m<sup>3</sup> loose block of Hawks Crag Breccia (circled) near the middle of the failure. Inset A: shows a view from rail height looking up the slope.**

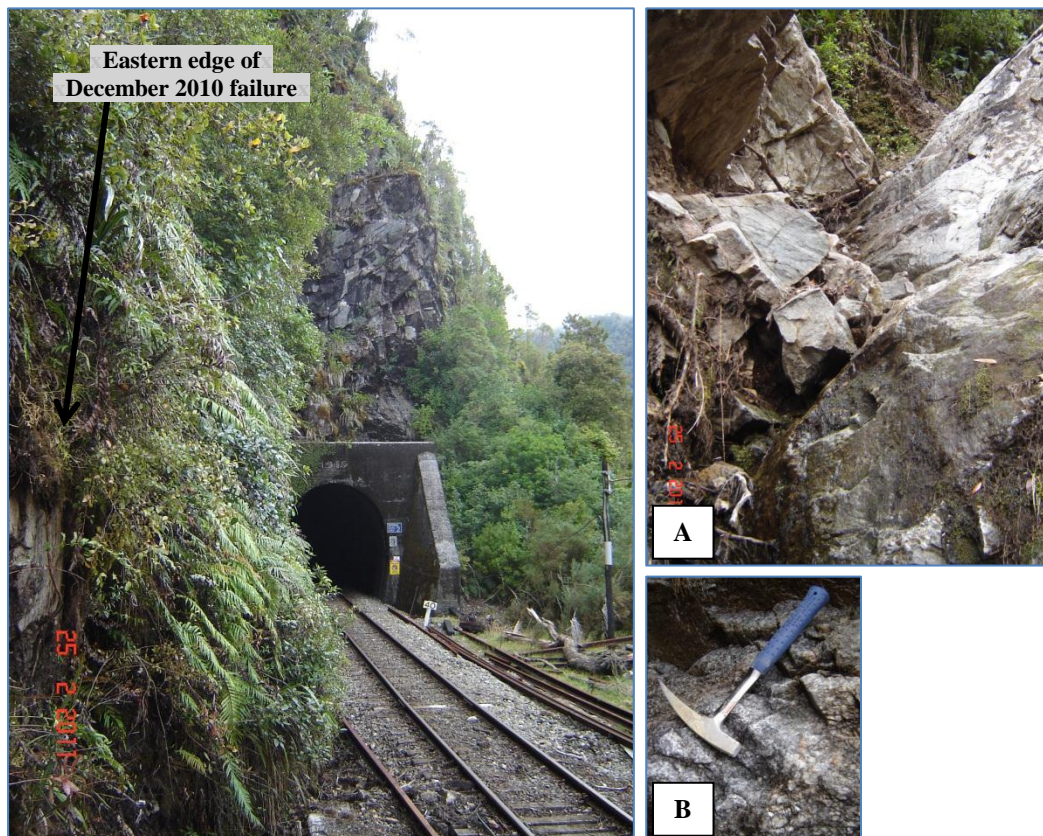
**Figure 5.9:** Location of landslide at SNL121.35km near the western portal of Tunnel 5 (edge of failure surface visible on lefthand side of photograph). Insets A and B show the failure surface and the granitic/gneissic rock type.

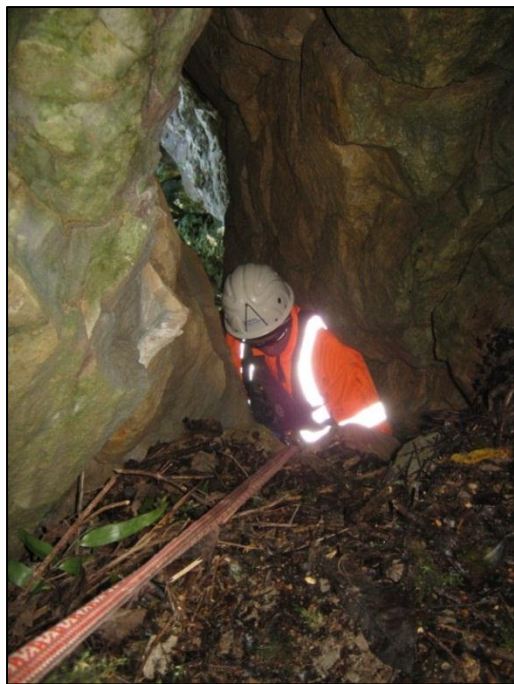
**Figure 6.6:** Start of Profile W1 descent at 140m elevation, near monitoring pin location. Limestone block on the lefthand side of the photograph is completely detached (volume of  $\sim 10\text{m}^3$ ).

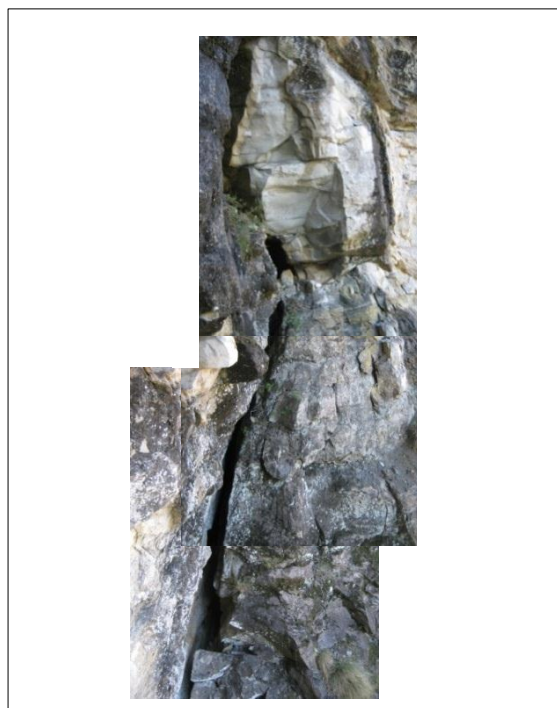
**Figure 6.8:** View of sub-vertical Fracture 2. Open around 200mm in this example from  $\sim 128\text{m}$  elevation.

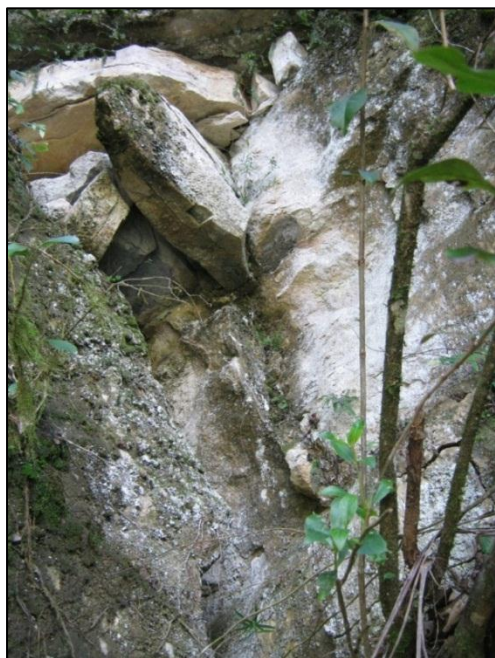
**Figure 6.10:** Start of Profile W2, looking northwards and back up the cliff at loose overhanging rocks.

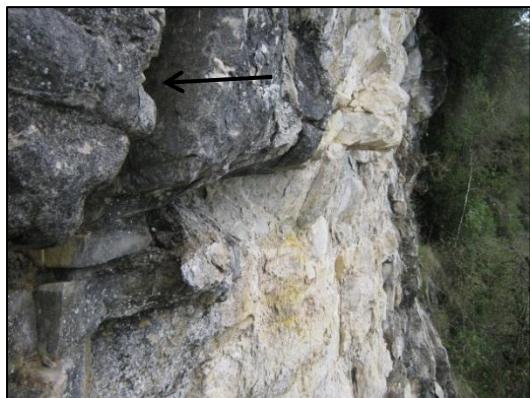
**Figure 6.12: Fracture 3 (arrow) around ~128m elevation. View east.**

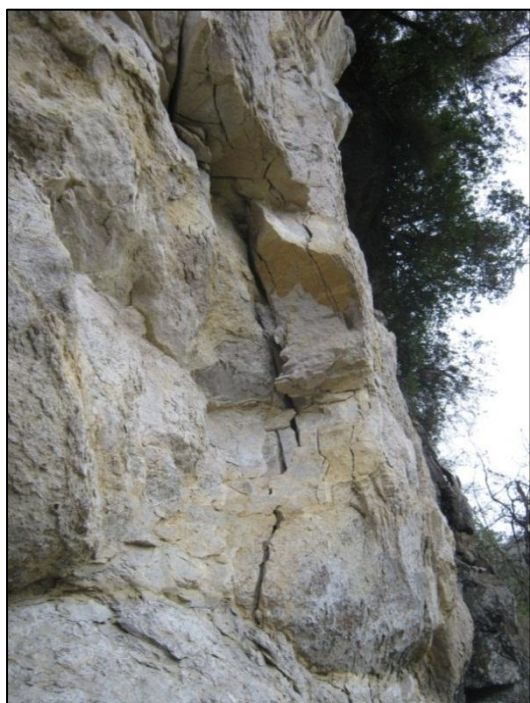
**Figure 6.15: Slab failure development in weathered surface of exposed cliff-face around ~119m elevation.**

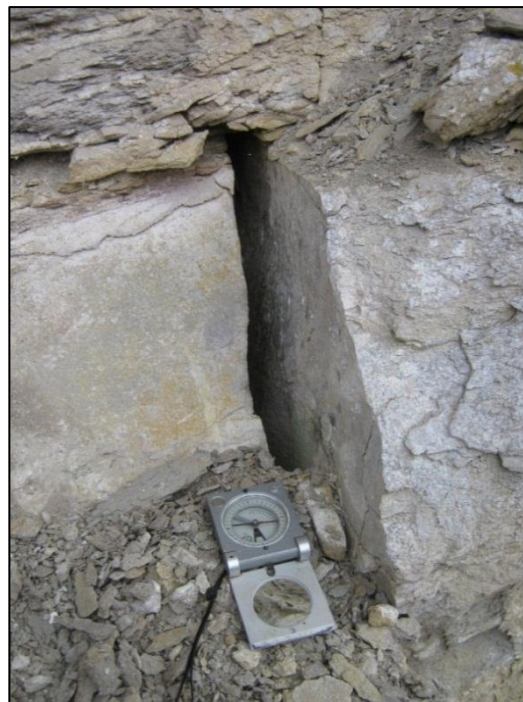
**Figure 6.14: Localised fracture observed at an elevation of ~118m. Note the finer grained mudstone near top of photograph (also shown in Figure 6.13).**

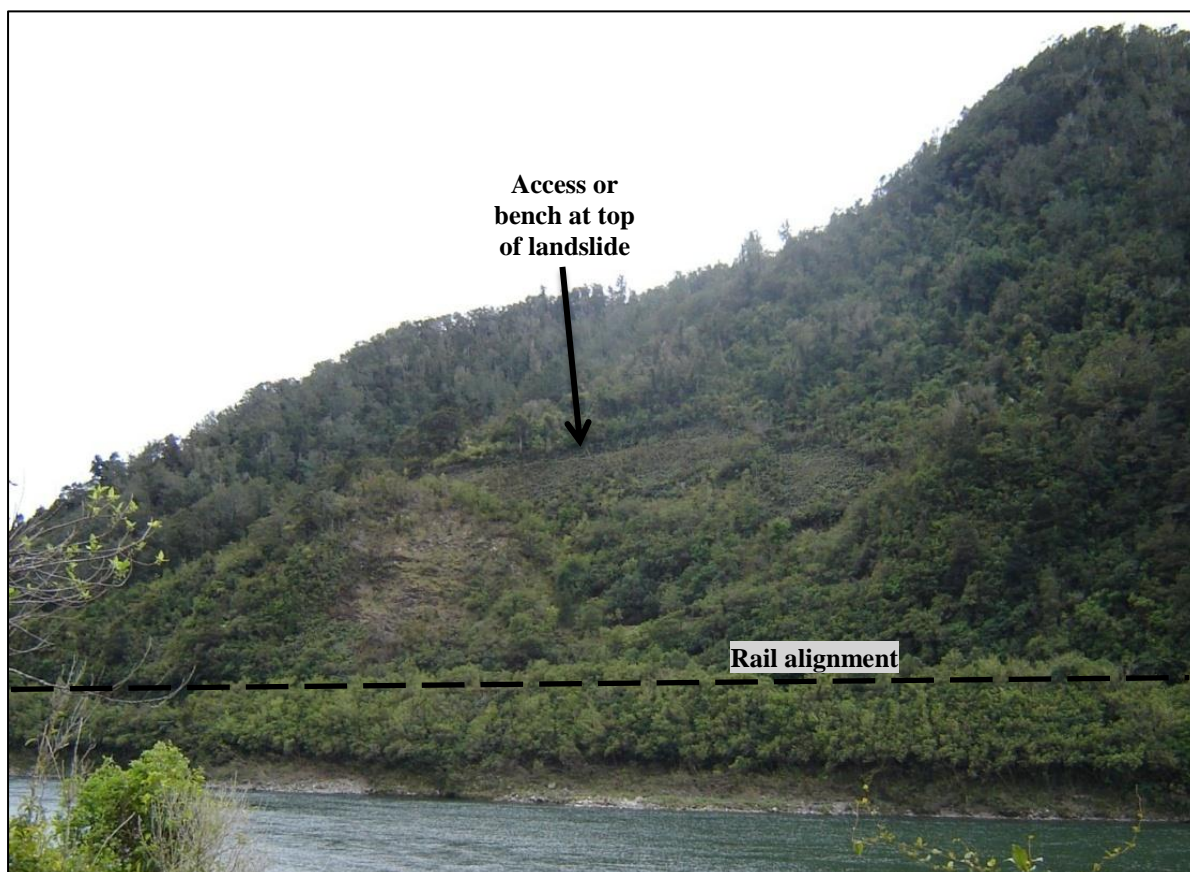
**Figure 7.9: View from SH6 of rail alignment and landslide above Windy Point (Tunnel 7) that occurred in January 1987 around SNL125.40km. The tunnel was subsequently daylighted.**

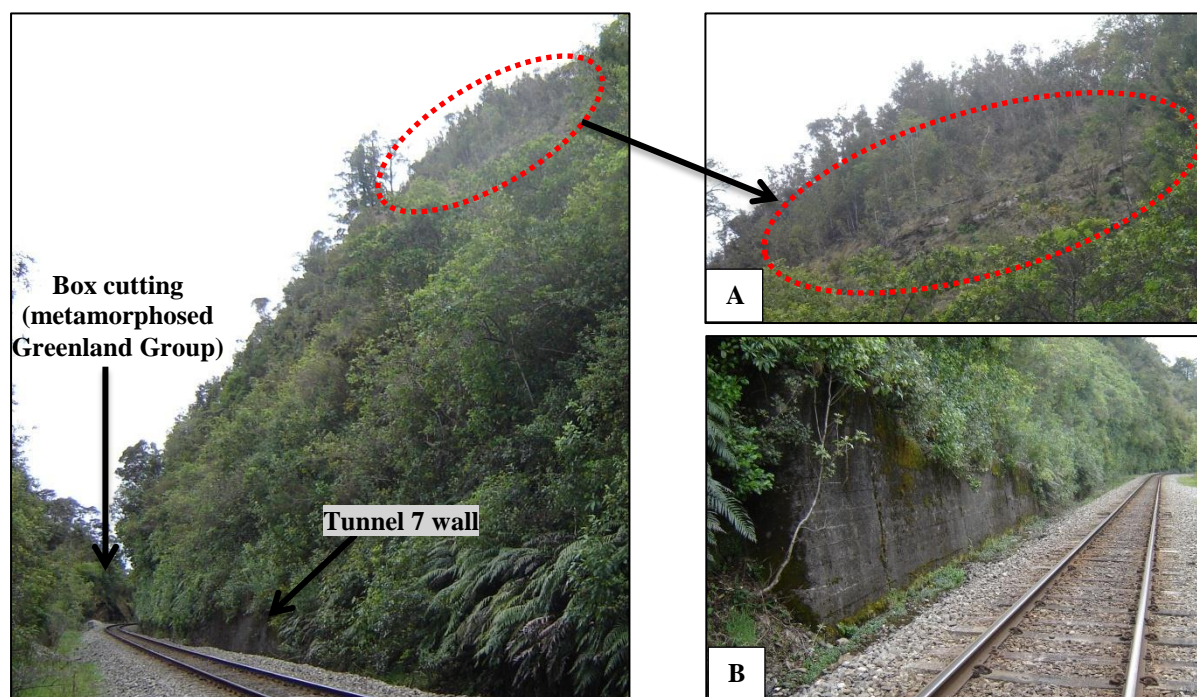
**Figure 7.10: View of Windy Point landslide looking west. Inset A shows the exposed bedrock near the top of the landslide, and Inset B the remaining Tunnel 7 wall (view looking east).**

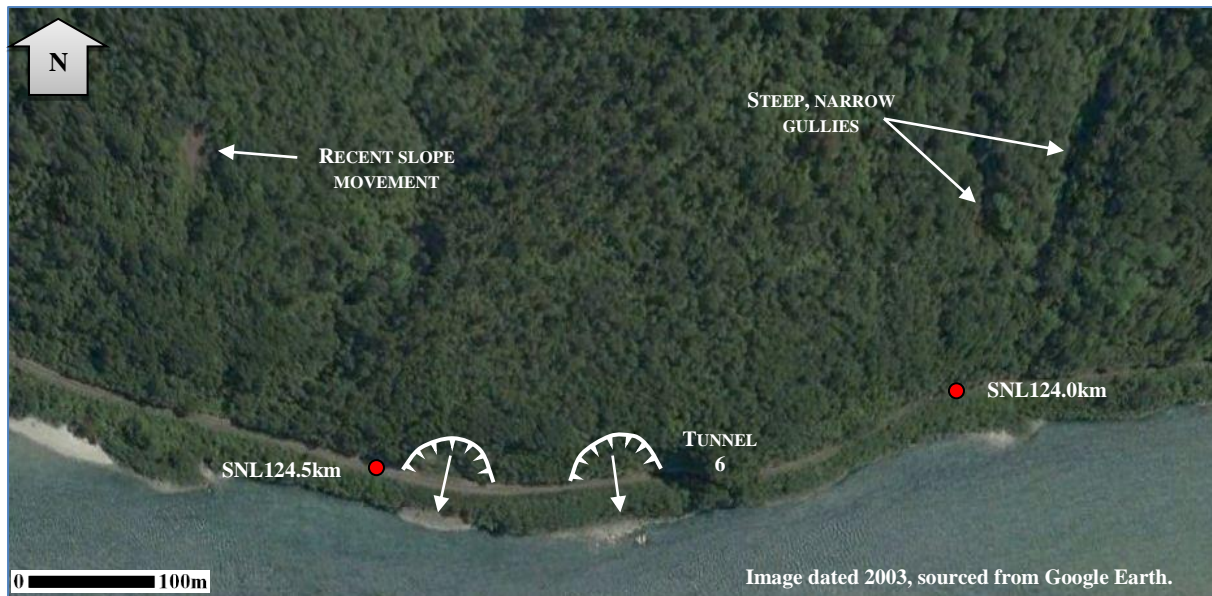
**Figure 7.11: Te Kuha speed restriction area. Slope movements highlighted on the western side of Tunnel 6. Arrows at higher elevations indicate other slope instability features and gullies.**

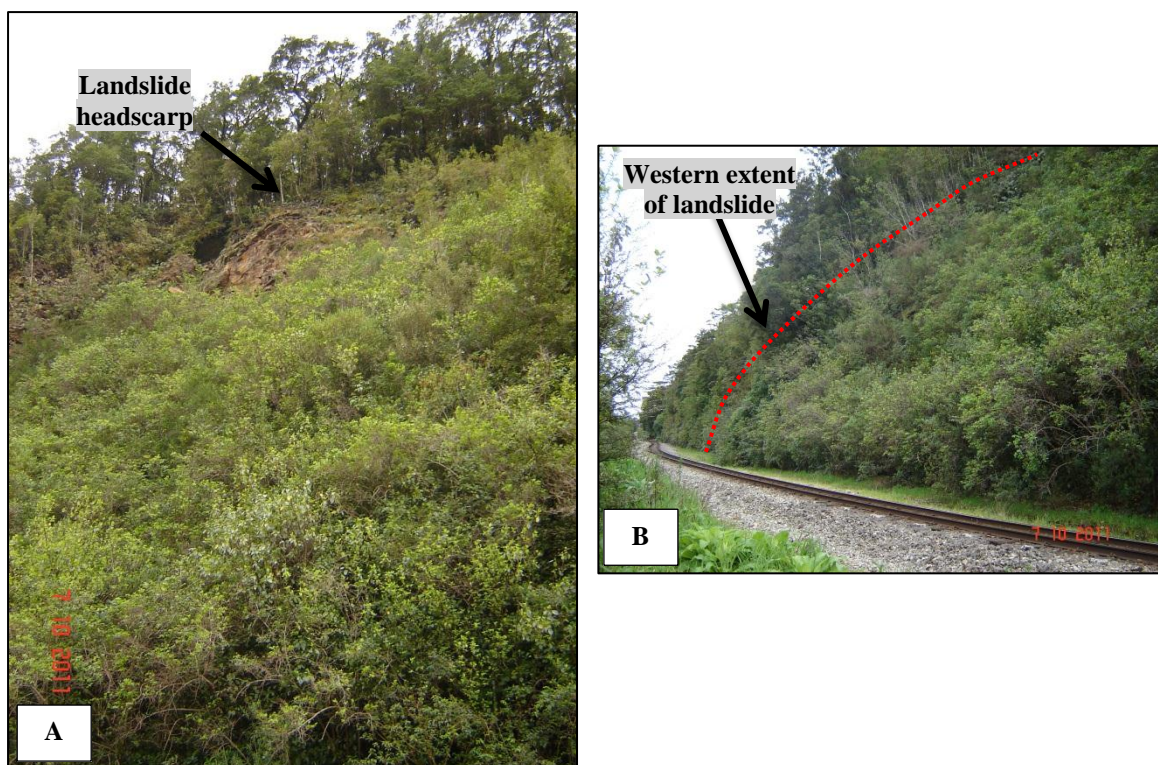
**Figure 7.13: Views of landslide ~100m west of feature shown in Figure 7.12 at ~SNL124.40, including landslide headscarp (A) and western lateral extent (B). Note extensive re-vegetation.**

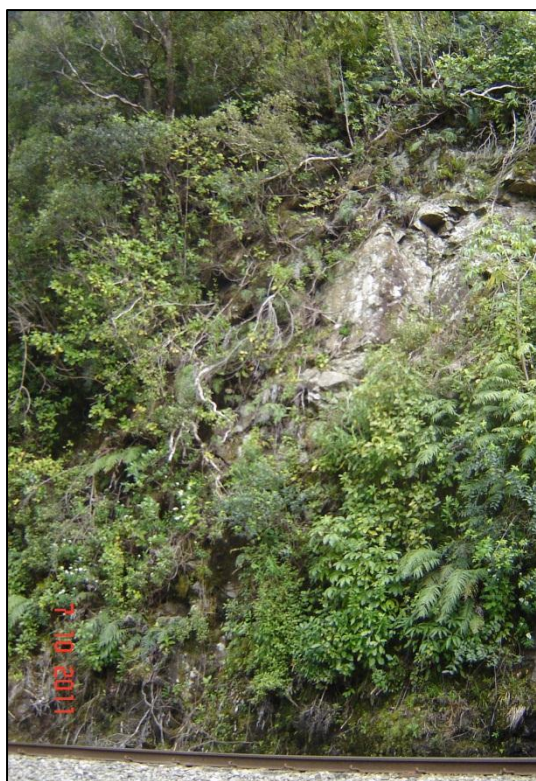
**Figure 7.15: Medium volume (~150m<sup>3</sup>) landslide in granitic regolith observed near SNL124.16km on 7 October 2011.**

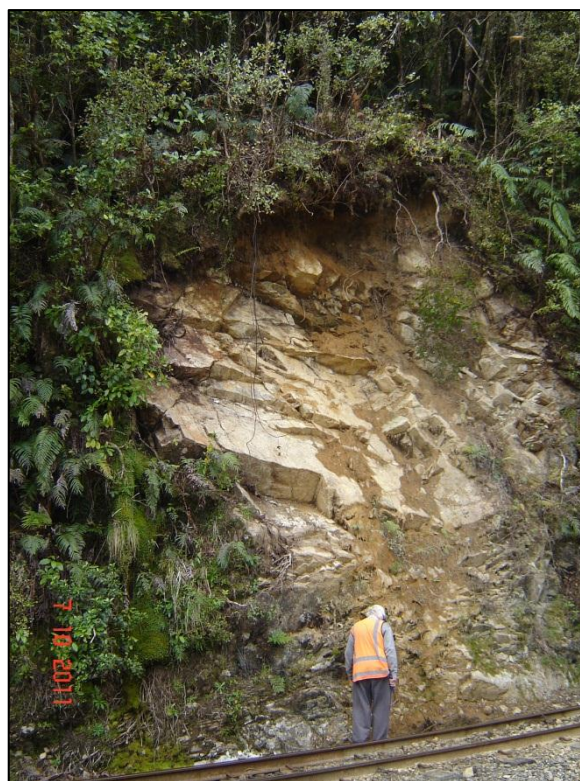
**Figure 7.16: Small volume (~80m<sup>3</sup>) landslide in metamorphosed Greenland Group observed on 7 October 2011 near SNL125.70km.**

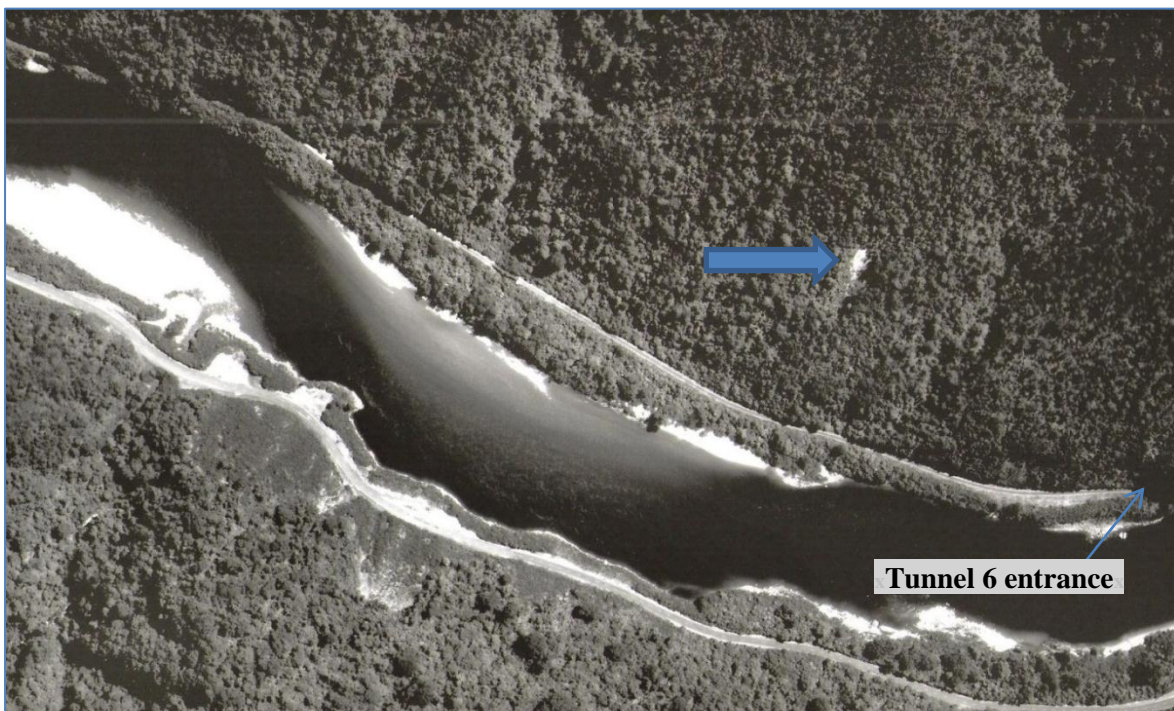
**Figure A3.2.4: Small slope movement feature above ~124.50km (indicated by arrow) in 1985 and slope instability issues adjacent to SH6.**

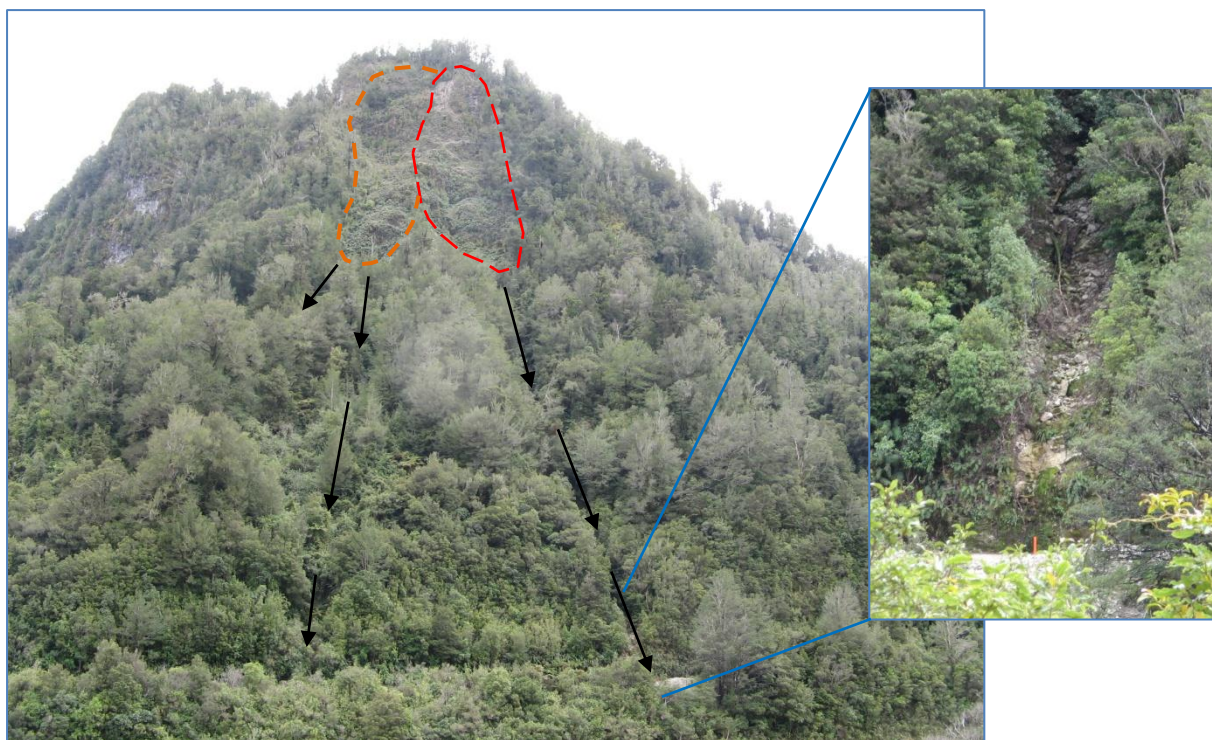
**Figure A5.9: View of failure surfaces outlined by orange and red dashed lines (source areas) at Sinclair Castle and travel path (track zone) of material that intersected the rail corridor. The red dashed lines indicate a comparatively more recent event in 2011, including the inset location at rail level.**
